Southern WV Safety Alert

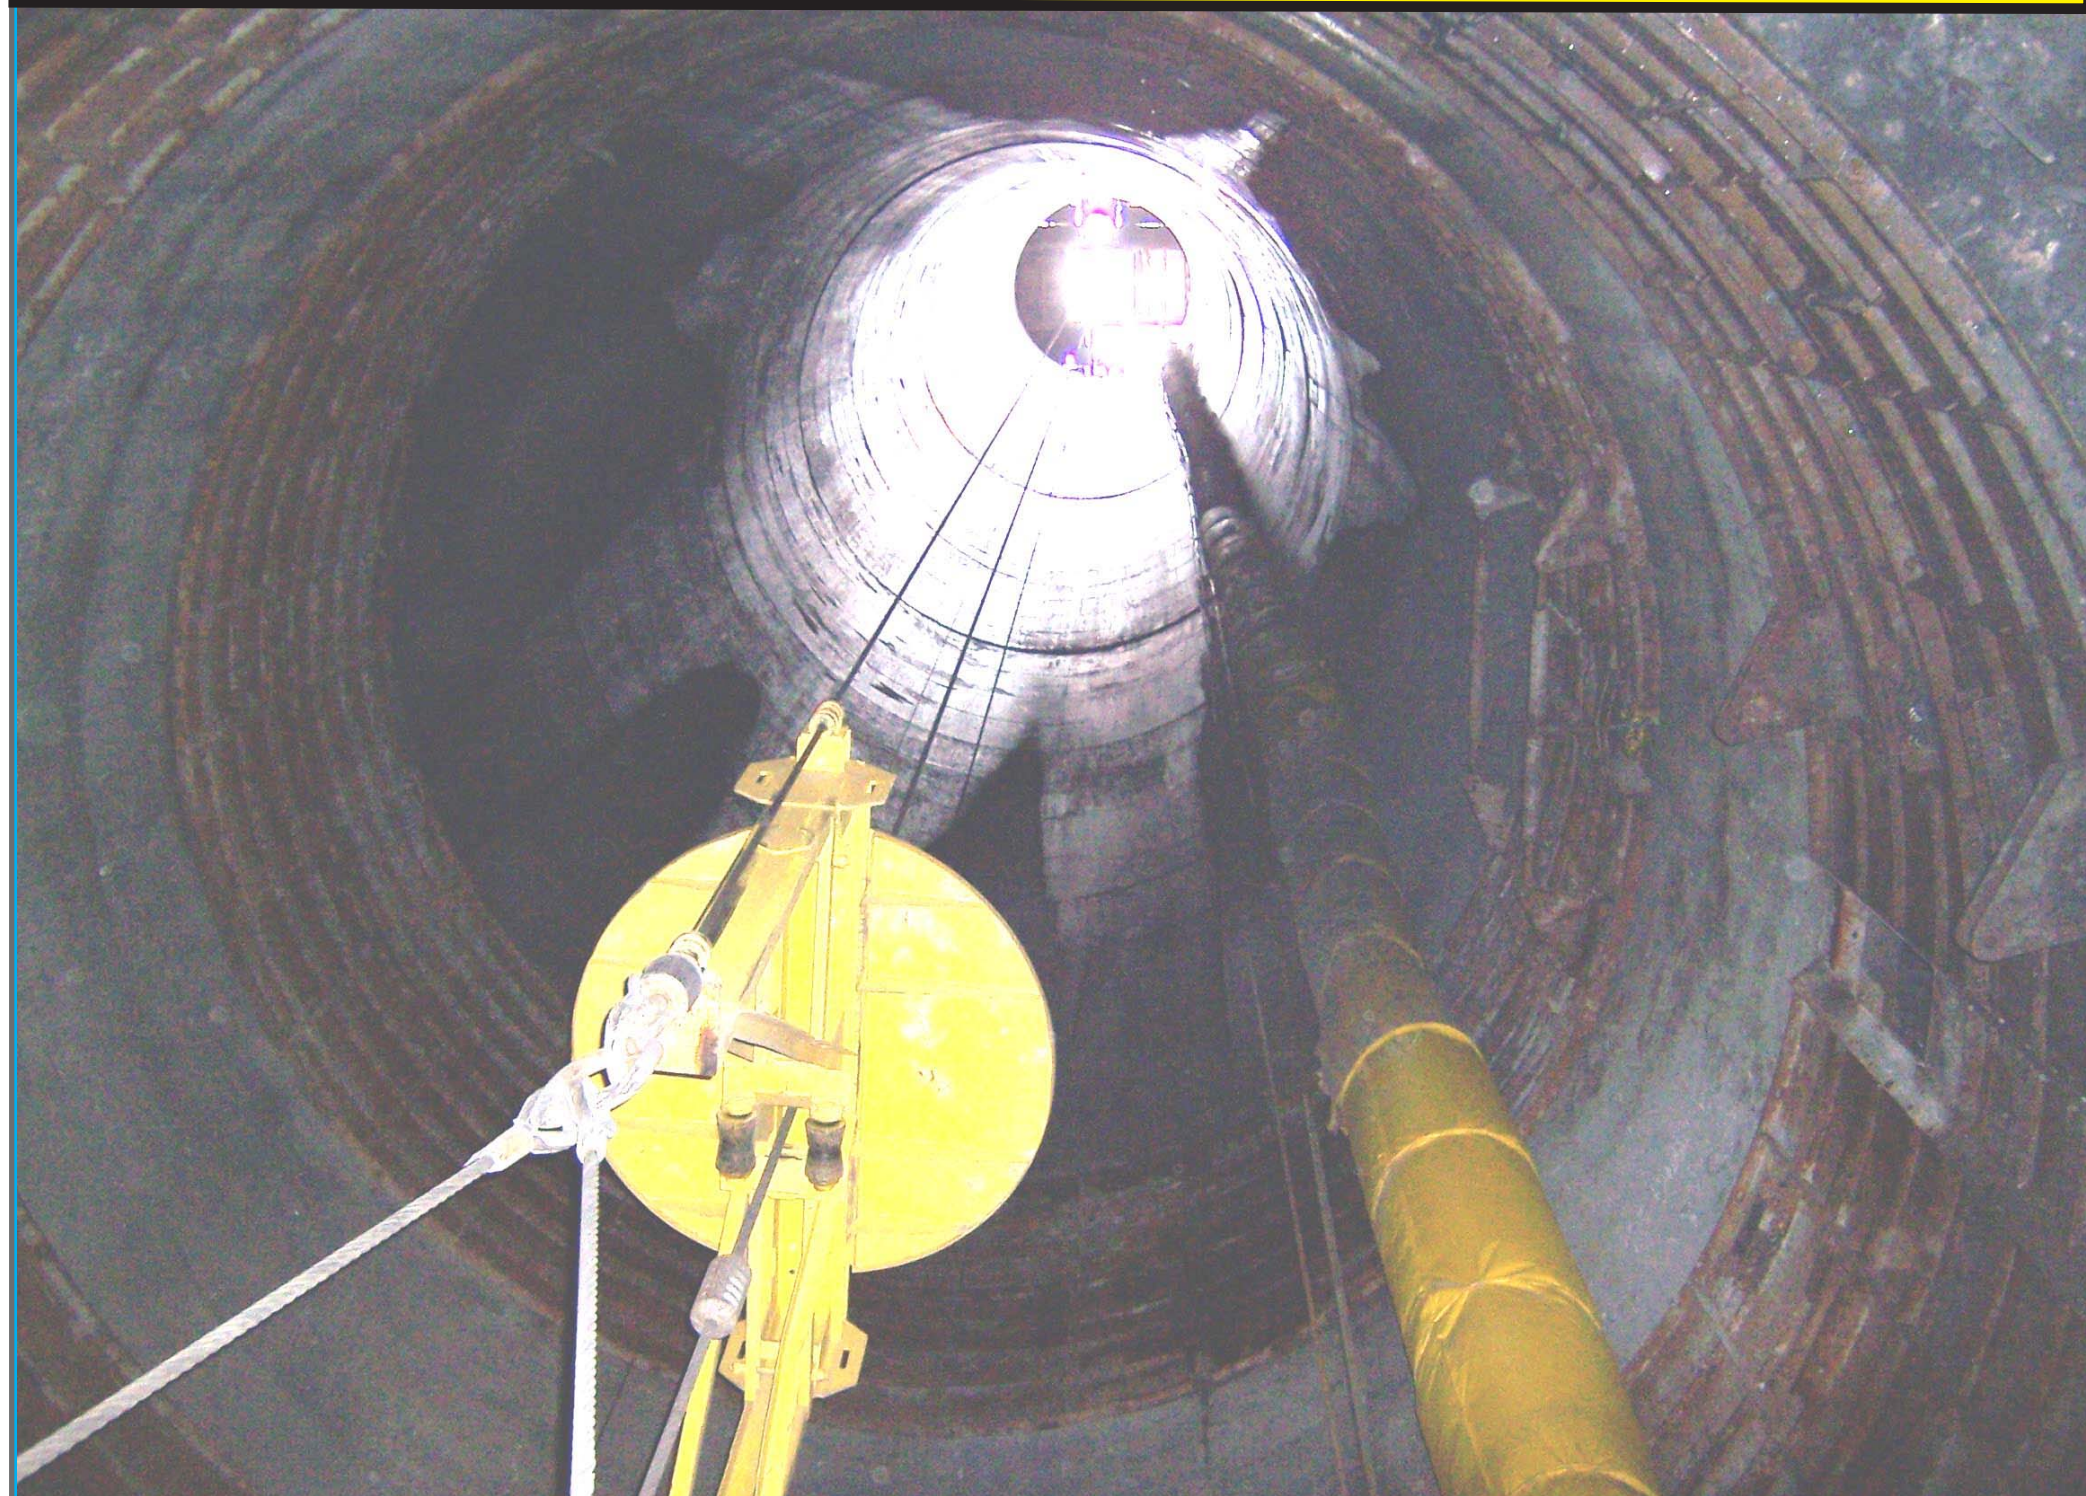
Recently an employee was performing work (mucking) at the bottom of the intake airshaft when a piece of concrete fell and struck him on the back portion of his hard hat. The fallen concrete measured 12 inches long, 8 inches wide, and 2 inches thick and fell from an I beam located 54 feet above the bottom of the shaft. The impact of the falling concrete caused the hard hat liner to break and cut the back of the employees' head.

- ✓ Adequate work place examinations must be conducted to identify hazards.
- ✓ Loose or dangerous material which creates a falling material hazard shall be corrected or barricaded to prevent exposure to the hazard.
- ✓ A safe means of access shall be provided and maintained to all working places.
- ✓ Work areas should be kept clear of spillage or debris to ensure safe workplaces.
